State of the Science: Plastic Pipe

Project #4680

Prepared by:

Katherine D. Martel and Ken Klewicki

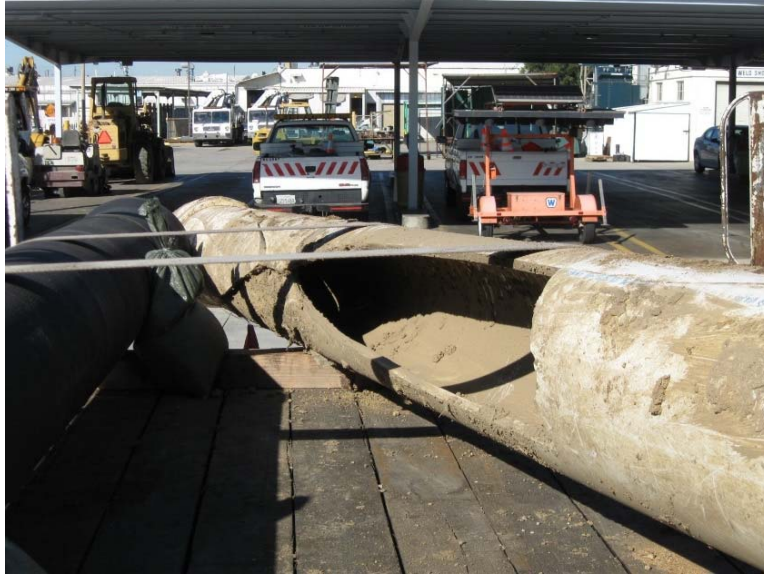
- LADWP experienced the failure of an AWWA C900 PVC pipeline due to large pressure fluctuations ([Figure 2.1](#)) (Bautista 2016). In 1992, an 875-foot (ft) section of 12-in. diameter C900 PVC pipe was installed as part of the LA Greenbelt Reclaimed Water Pipeline. The pipeline is located along the south side of the Los Angeles River from Barham Boulevard to the end of the line at the Universal Studios customer's meter. The pipeline is located in the Recycled Water 740 pressure zone which has an operating pressure of 90 psi and surge pressures that can exceed twice the operating pressure. The PVC portion of the pipeline had three breaks from 2008 to 2010 and three more breaks in 2011. All segments of this PVC pipeline have since been replaced with DIP and no further breaks have been reported by LADWP.

Figure 2.1 AWWA C900 PVC pipe failure in 2009 due to large pressure fluctuations

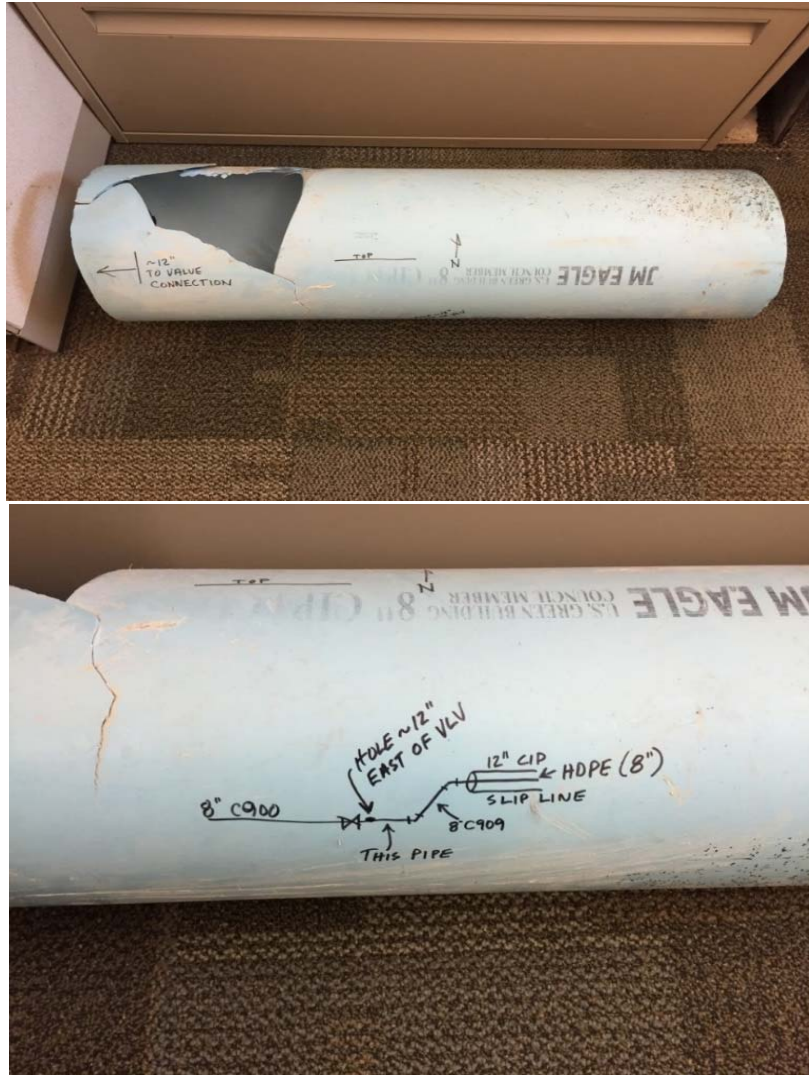
- WaterOne in Johnson County, Kansas experienced the failure of an 8-in. diameter PVC (C909) pipe at a tie-in just outside of a 12-in. diameter sliplined CIP ([Figure 2.2](#)) (Pietig 2016). The failure was due to movement (i.e., expansion, contraction) of the 8-in. diameter HDPE pipe inside the 12-in. diameter CIP and improper use of a PVC locking wedge-type restraint product on C909 pipe for which the product was not rated. The movement of the HDPE pipe increased the stress at this connection point, and the pipe failed right at the mechanical joint fitting. The pipe was installed in 2014 and the failure occurred in 2015. The repair costs exceeded \$26,000. WaterOne uses both C900 and C909 PVC pipe, but the locking-wedge-type restraint should have only been used on the C900 pipe.

Figure 2.2 PVC (C909) pipe failure at WaterOne

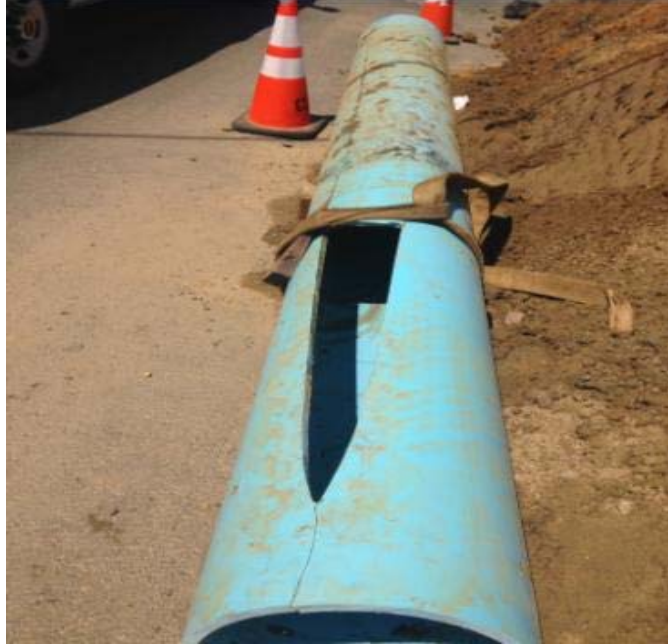
- American Water reported on a PVC pipe failure during a tapping event (Figure 2.3). The causative factors included pipe class selection (i.e., the pipe wall thickness); the selected tapping saddle; the tapping speed; and the tapping location (i.e., tapping on the top of the pipe places the highest stress on the pipe) (Hughes 2016a). The tapped hole on one failed pipe showed some burned PVC material on the cut surface that served to weaken the PVC pipe. Tapping heat can be generated by a dull cutter, lack of lubrication, or cutting at an excessive speed (Hughes 2016a).

Figure 2.3 PVC pipe failure due to tapping at California American

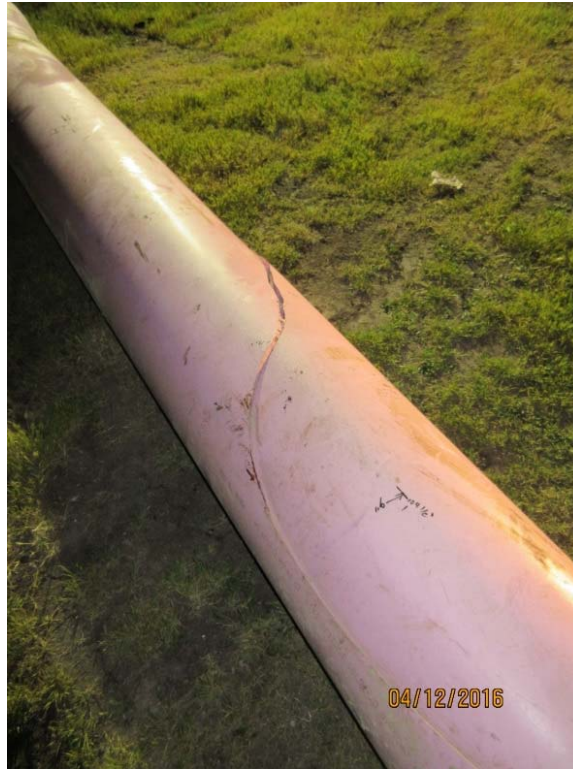
- EBMUD has had tapping failures that resulted in long, rapid cracks in PVC and FPVC pipe (Figure 2.4) (Irias 2016).

Figure 2.4 PVC pipe failure due to tapping at EBMUD

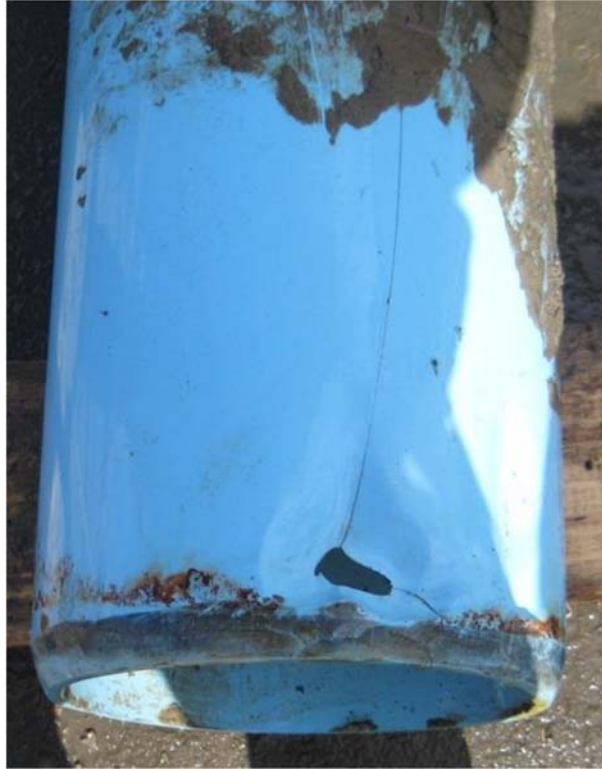
Figure 2.5 Erosion of pipe material from a poorly sealed joint

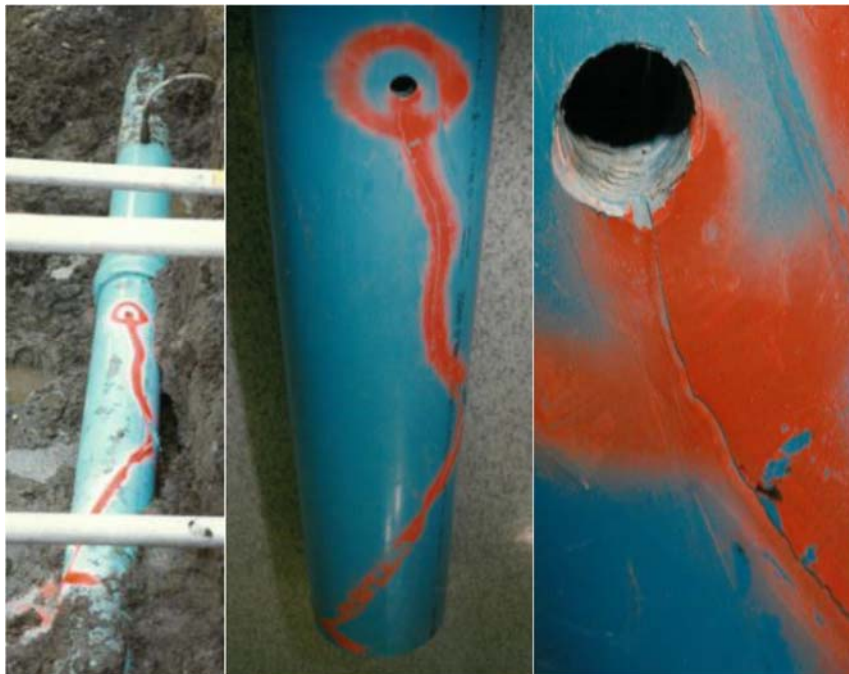
Figure 2.6 PVC Pipe split when water service hit during construction

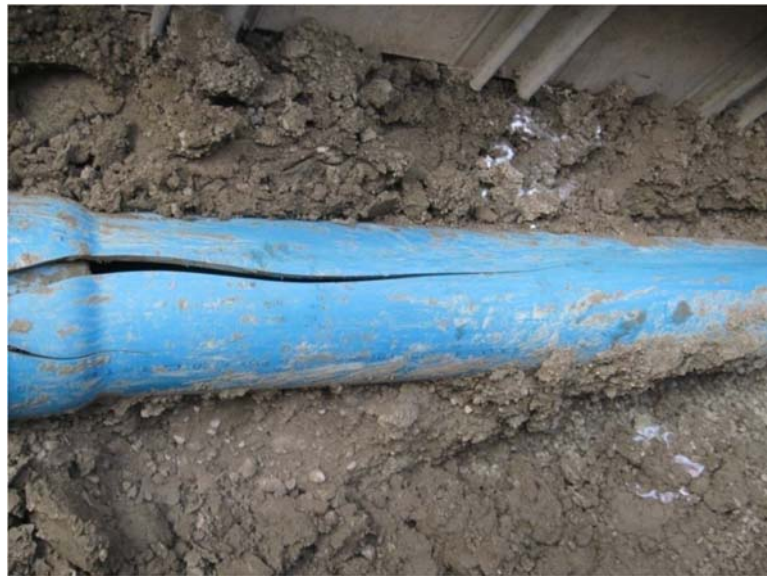
All of the 20 PVC pipe failures recorded from 1991 to 2004 in Calgary were due to installation errors (e.g., cracks that propagated from a tapping point or a saddle clamp, leakage at a gasket, pipe deflection) and occurred in pipe that was between 2 and 17 years old (Brander 2004). Dueck (2010) identified the probable causes of three PVC pipe failures that occurred in 2008-2009. For example (Figure 2.7), the failure of a 7-year-old, 250 mm (10-in.) PVC pipe (SDR 18) in December 2008 included several probable causes: over-insertion of spigot into bell, soil movement (bedding conditions), and longitudinal bending combined with joint deflection. The lack of vertical separation from an existing utility was identified as the cause of other failures studied.

Figure 2.7 City of Calgary PVC pipe failure in December 2008

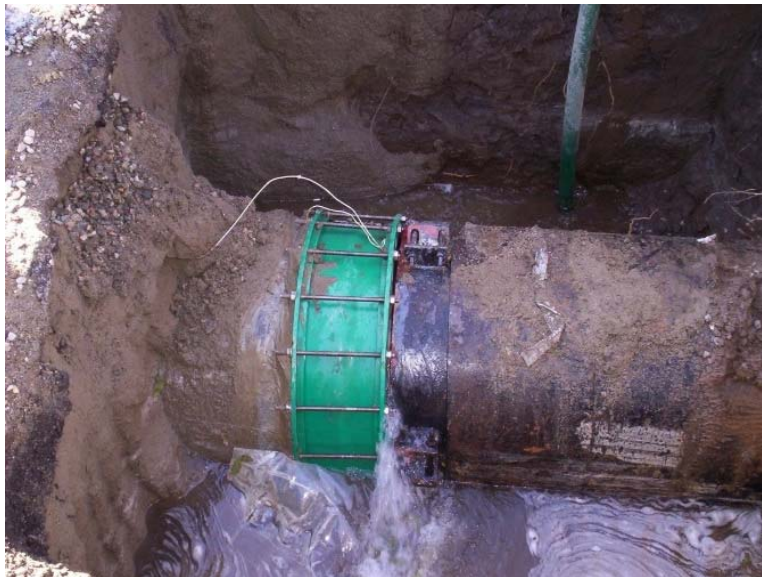
- In 2007, LADWP experienced a leak on an HDPE coupling ([Figure 2.8](#)) connecting HDPE and steel pipelines. Thermal expansion and contraction of the pipe materials, which created stress on the end connections, were believed to be the cause of the leaks (Bautista 2016).

Figure 2.8 HDPE coupling leak at LADWP

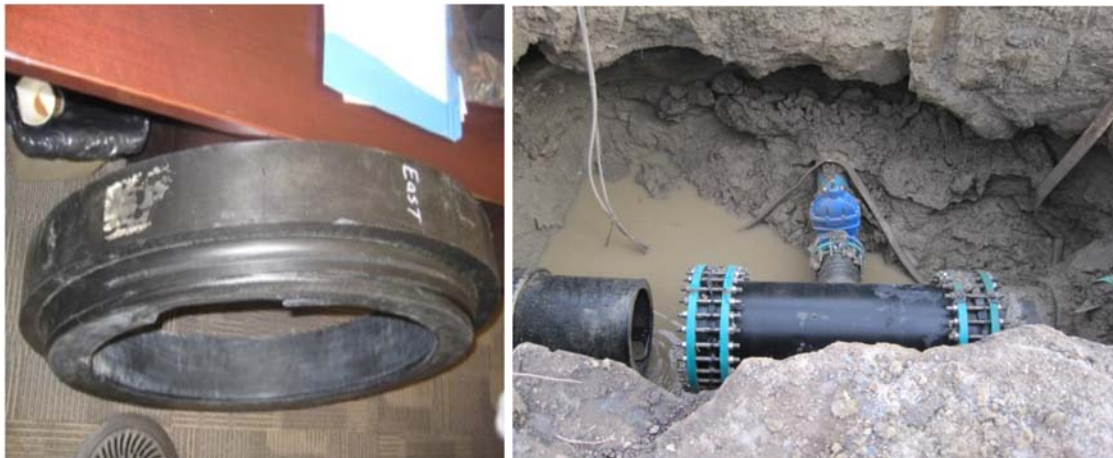
A butt fusion joint failure occurred in February 2011 when the joint at the stub end totally separated by at least 457 mm (18 in.). The HDPE pipe, installed in 1995, had an OD of 686 mm (27 in.) and an inside diameter of 580 mm (23 in.). The pipe was sliplined inside a 762-mm (30-in.) steel water transmission main. The failure was attributed to cold fused areas (Seargeant 2016). The pipe was installed at a warmer temperature during summer months and the fused joint failed at colder temperature when the water in the pipe was at its coldest. The annual change in water temperature ranged from 1 degree C to 23 degrees C.

Figure 2.9 HDPE butt fusion joint failure in Edmonton, Canada

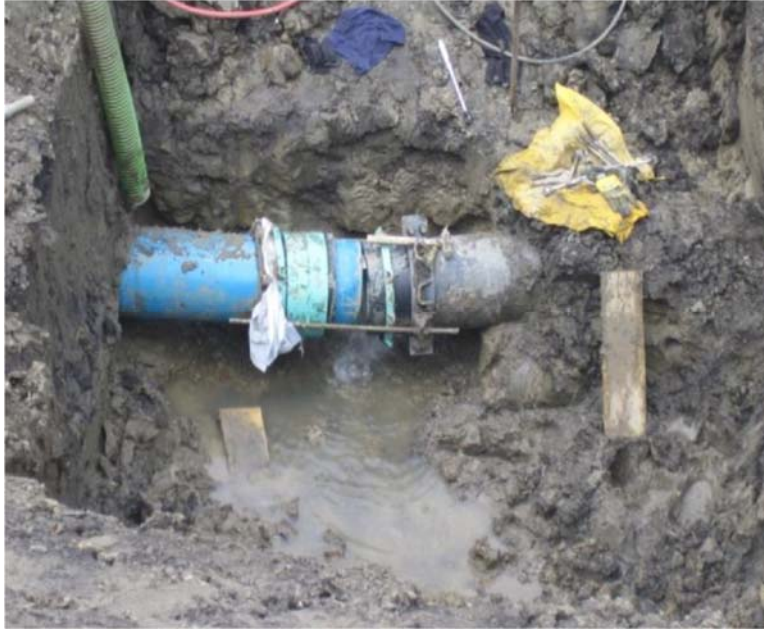
- Restrained mechanical coupling leak (Figure 2.10)

Figure 2.10 Restrained mechanical coupling leak at transition from HDPE to PVC

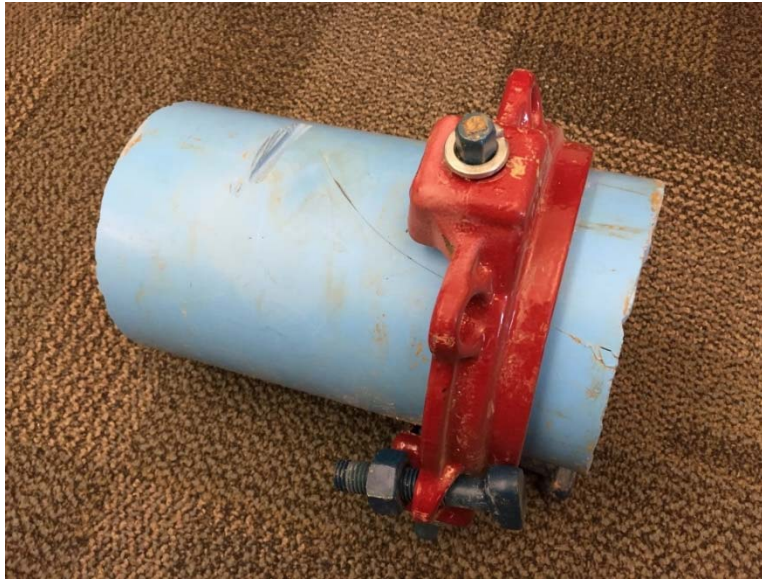
- EPCOR Water in Edmonton saw initial installation problems with PVC in the late 1970's (Sergeant 2016). The problems were overcome with support to contractors from the manufacturer and diligent inspection of construction.
- In 2013, WaterOne experienced the immediate failure (i.e., split) of a 6-in. diameter PVC (C900) pipe at a connection to a DI fitting with a wedge-restraint device (Figure 4.2) (Pietig 2016). The connection was performed in sub-freezing January weather. Other possible causative factors were an improper bolt tightening procedure and a rough, jagged saw cut at the end of the pipe.

Figure 4.2 WaterOne PVC (C900) pipe failure
